Manhole Inspection Summary

Manhole # S11AA2002MH

Location Address: **2402 BRAMBLETON RD** Cross Street: **GREENSPRING AVE**

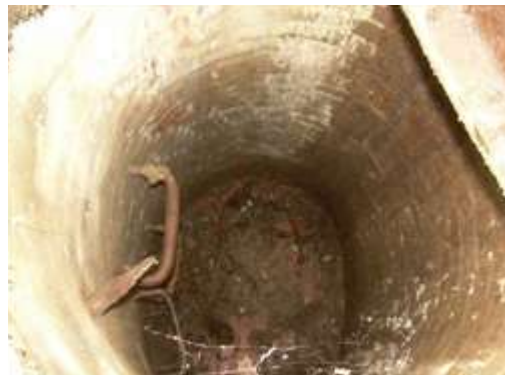
Top View

Corroded and missing steps. Channel debris.

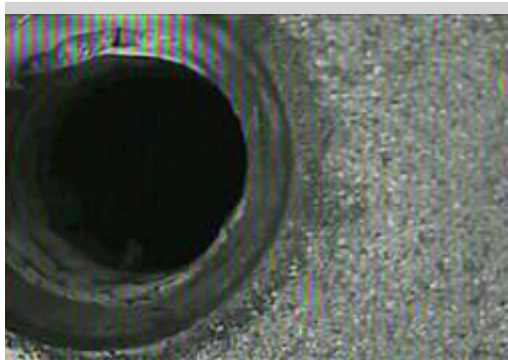
Frame offset

Frame offset.

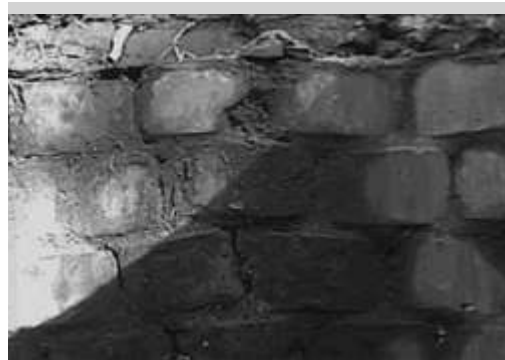
Defect

Adjustment deterioration and infiltration.

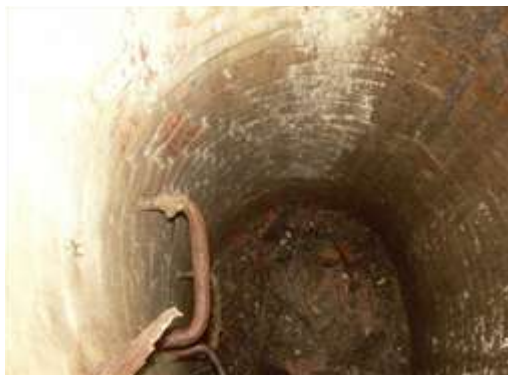
Defect

Adjustment, Corbel and Barrel infiltration.

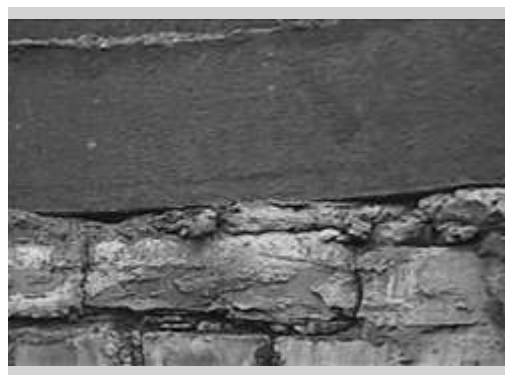
Defect

Frame leaks. Adjustment deterioration and infiltration.

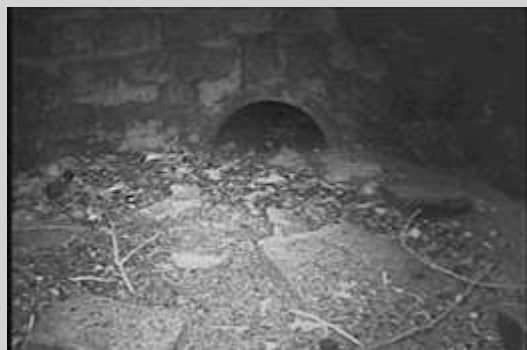
Pipe Out @ 12 O'Clock

Channel debris.
